**Type B Accident Investigation Report
of the April 23, 1997, Helicopter Accident
at Raton Pass**

May 1997

**Western Area Power Administration
U.S. Department of Energy**

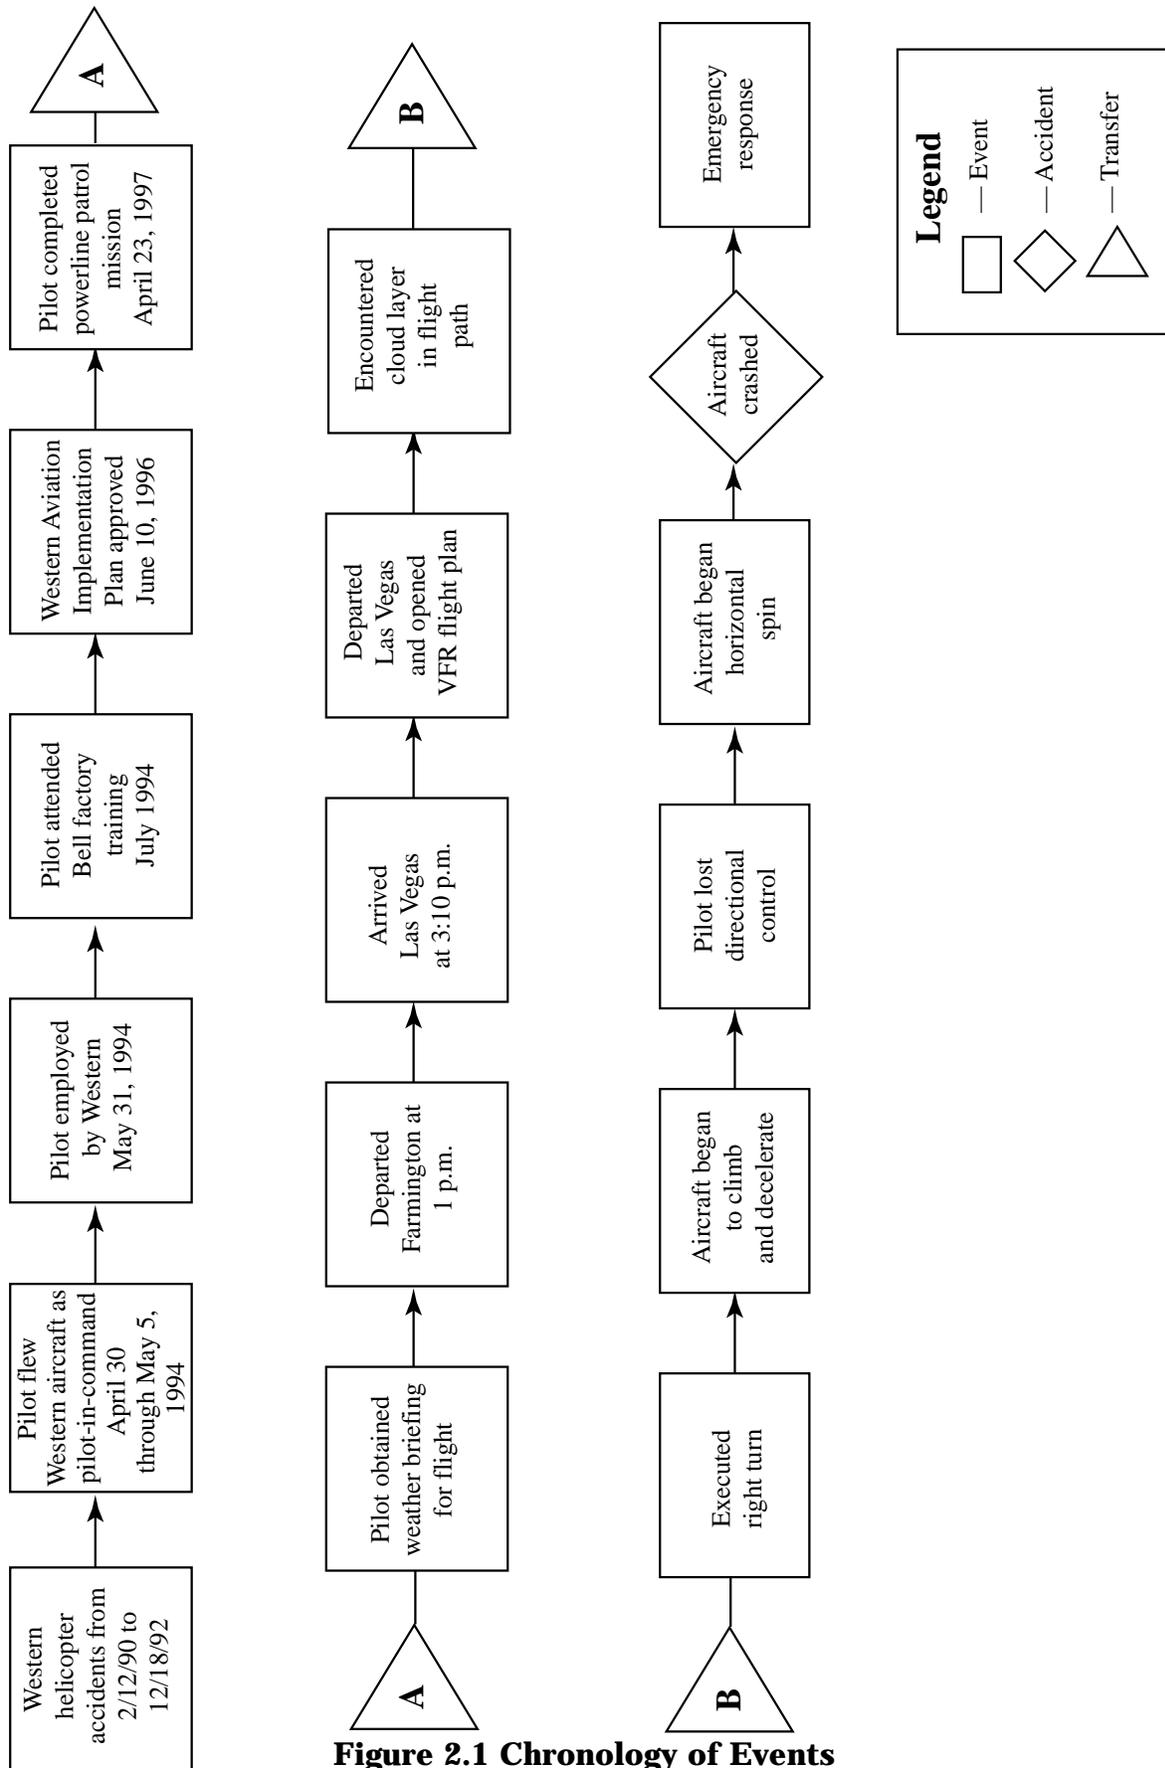
Figure 2.1 Chronology of Events

See Figure 2.1 for a summary of the chronology of significant events.

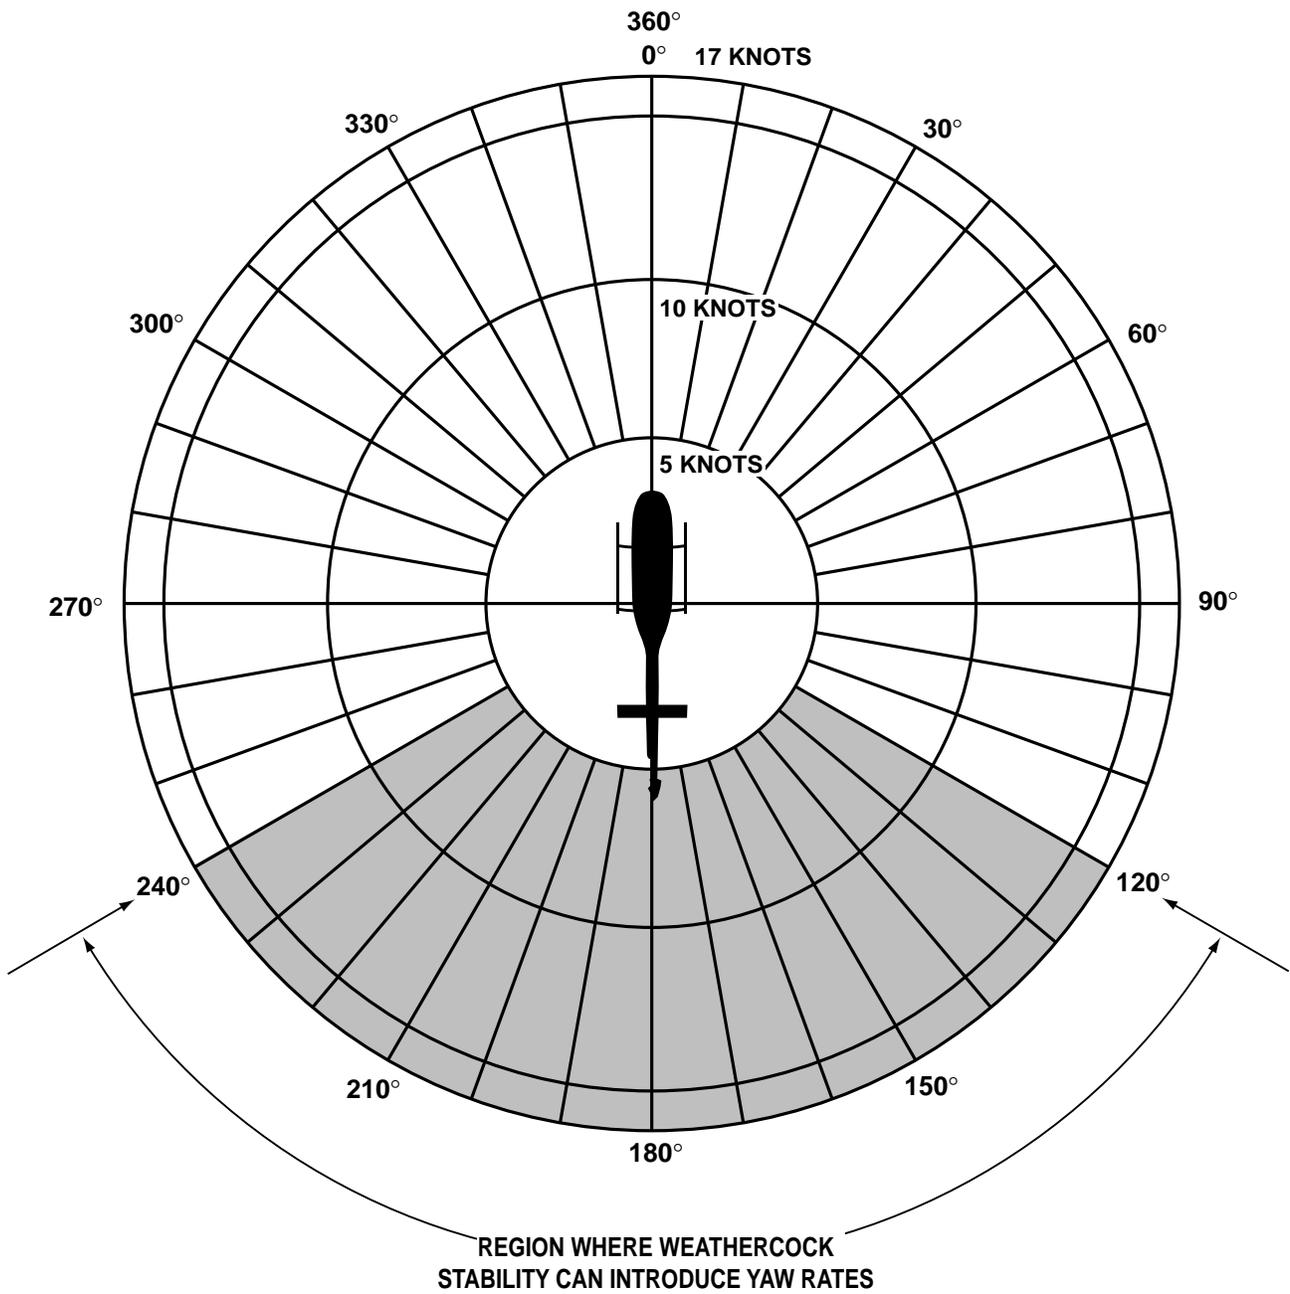
Figure B-1
Weathercock Stability

Based upon the Pilot's description of the accident and onsite examination of the wreckage, the Board examined loss of tail rotor effectiveness (LTE) as a possible contributing factor in the accident. LTE is a flight characteristic that occurs under certain conditions in various models of helicopters, including the Bell 206 series, which can result in a rapid uncommanded right yaw (horizontal rotation) and loss of control of the aircraft. LTE may occur in certain relative wind conditions at slow airspeeds. A detailed discussion of LTE can be found in Appendix B.
